Choice Home Inspection Services, Inc.

Property Inspection Report

555 Main Street, Atlanta, GA
Inspection prepared for: Mr. and Mrs. Client
Date of Inspection: 4/11/2017 Time: 2:00 PM
Age of Home: 2001 Size: 1952
Order ID: 1470

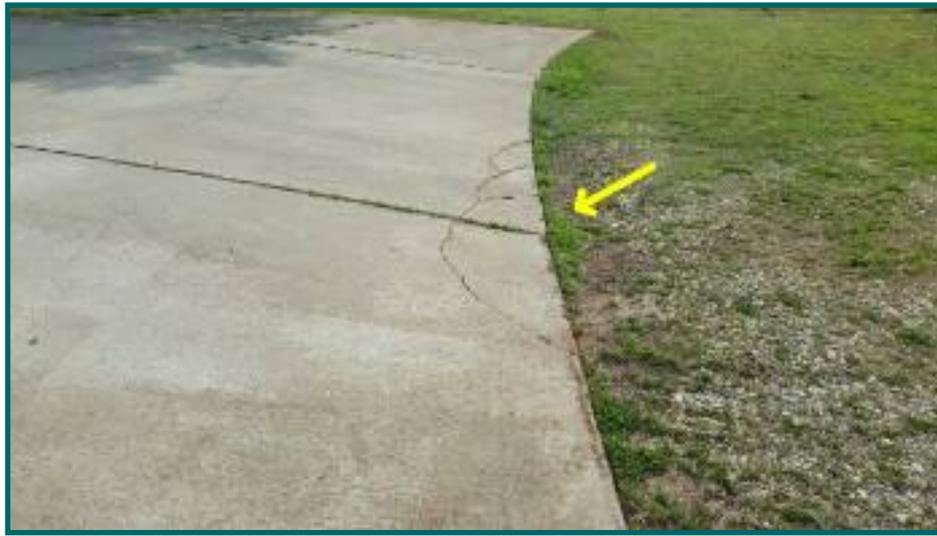
1.1. The soil below the driveway has settled and/or heaved. Persistent movement may result in the need for replacement or resurfacing in the future. The cracks in the driveway need to be sealed to prevent further damage. The freeze thaw cycle may cause differential settlement and enlarge existing cracks.

settling noted in the driveway

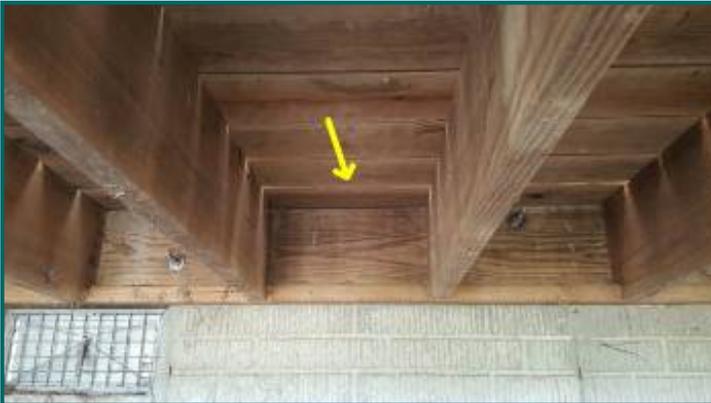
4.3. The flashing between the porch and the house is not visible. Recommend a licensed contractor verify the presence of the flashing or install as needed per the generally accepted building practices and repair any resulting moisture damage to the exterior wall.

flashing is not visible at porch

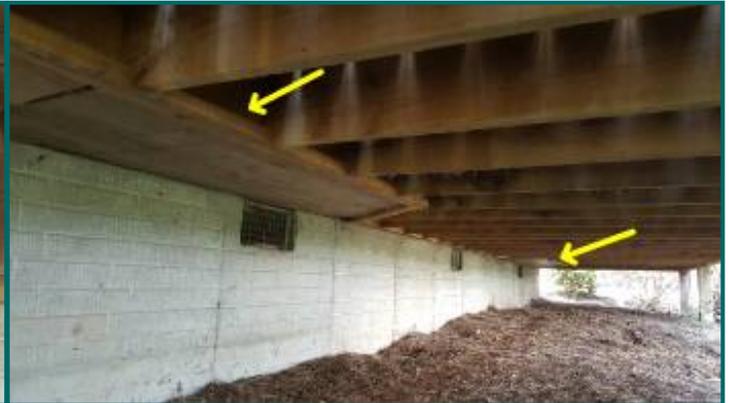
4.2. The porch is connected to the cantilevered rim joist at the house. This is not allowed by building industry standards and the cantilever is not designed to carry the extra load. This is a potential structural support issue that should be corrected. Recommend a licensed building contractor add framing around the chimney or bay window or add post and beam per the normally accepted building practices.

porch connection to cantilever

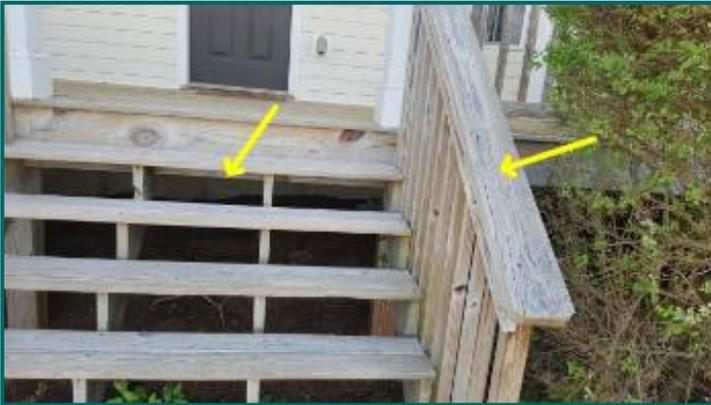
5.1. For improved safety, it is recommended that a graspable handrail be provided for the exterior stairway. The handrail is not the proper configuration or dimension; recommend a qualified contractor install per the generally accepted building practices and make any other repairs needed at that time.

5.2. Open risers between steps greater than 4" which should be covered if small children are present for reasons of safety. Recommend a qualified trades person repair as needed and make any other repairs needed at that time.

handrail is not graspable and open risers

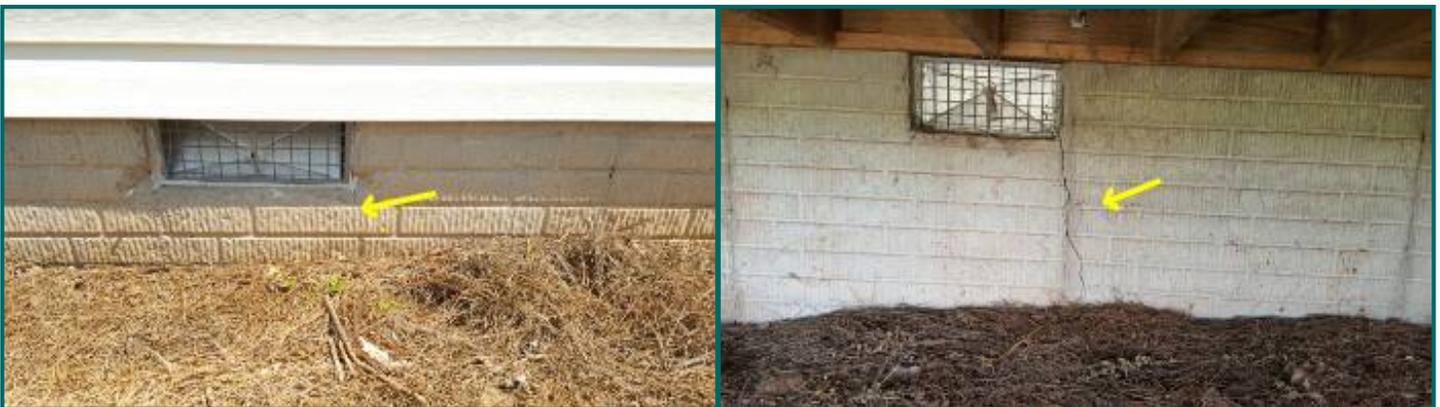
1.1. Minor 1/32nd and 3/8th inch settlement cracks were observed in the foundation wall(s), the crack(s) may need sealing to prevent moisture penetration. This implies that some structural movement of the building has occurred. Cracks of this type should be watched for any sign of additional movement. In the absence of any sign of ongoing movement, repair should not be necessary.

minor foundation crack on right

minor foundation crack at front

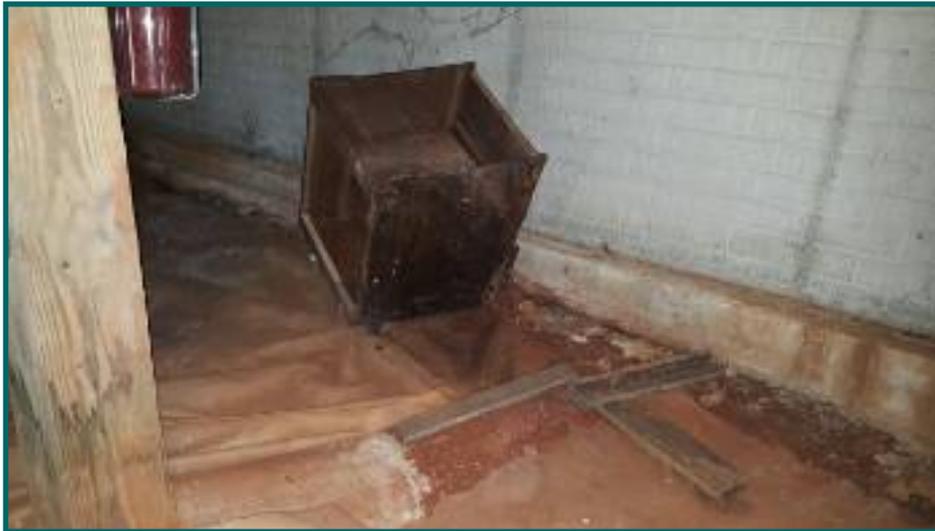
3.1. All wood debris and/or trash should be removed from the crawl space. Organic debris around a property increases risk of insect or rot damage and make any other repairs needed at that time.

wood debris and/or trash

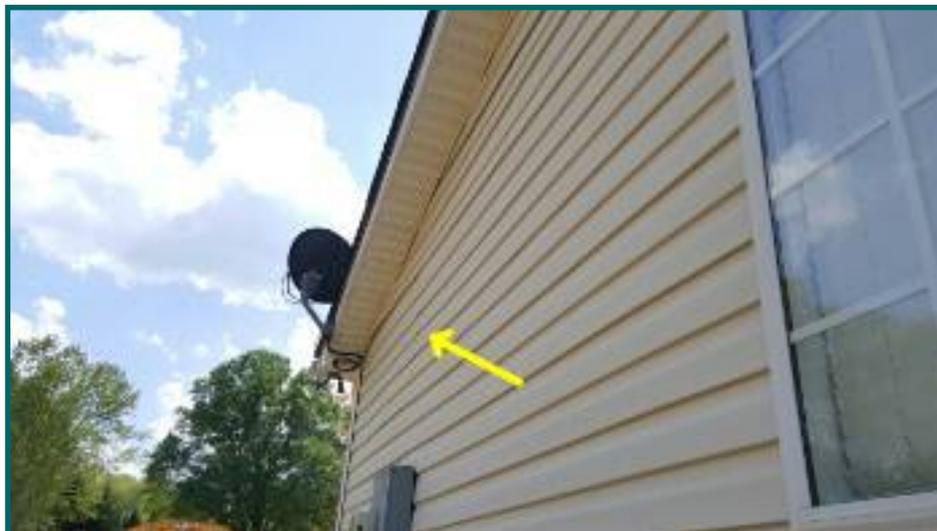
2.1. The loose siding on the house should be secured by a qualified trades person to avoid wind damage and make any other repairs needed at that time.

loose siding on left

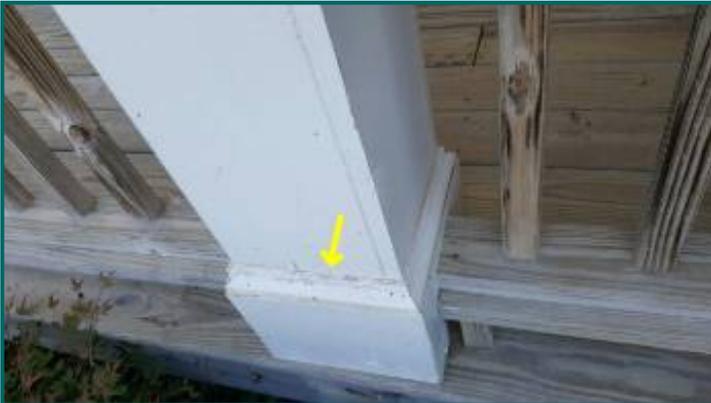
3.1. Localized wood deterioration on the house was observed in the trim around the front porch columns. We are unable to determine the condition of the underlying material. Recommend a qualified contractor check all of the trim and replace as needed, and caulk and paint to match the existing trim and make any other repairs needed at that time.

deteriorated trim around the front porch columns

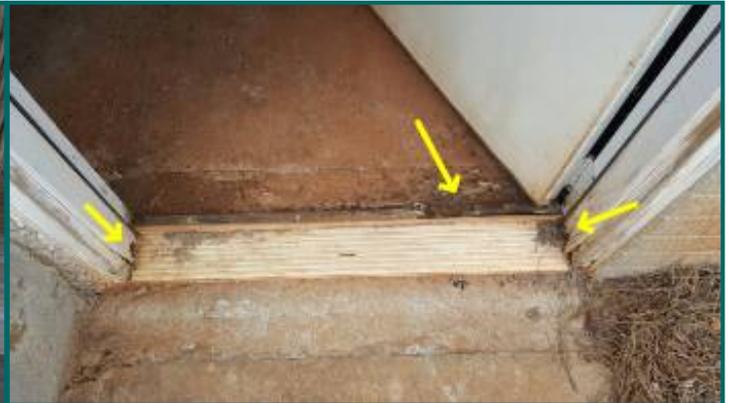
3.2. Localized wood deterioration on the house was observed in the threshold and trim around the door(s). We are unable to determine the condition of the underlying material. Recommend a qualified contractor to check all the trim and replace as needed, and caulk and paint to match the existing trim and make any other repairs needed at that time.

deteriorated threshold and trim around the crawlspace door

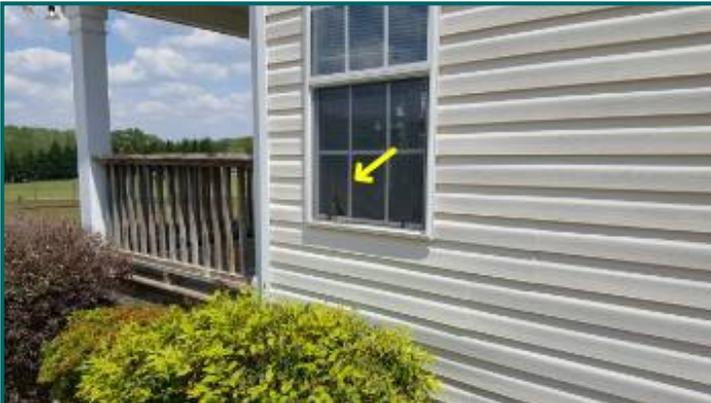
4.1. Observed the window screen(s) are damaged on the house. Recommend a qualified contractor replace screens where damaged.

damaged screen on right

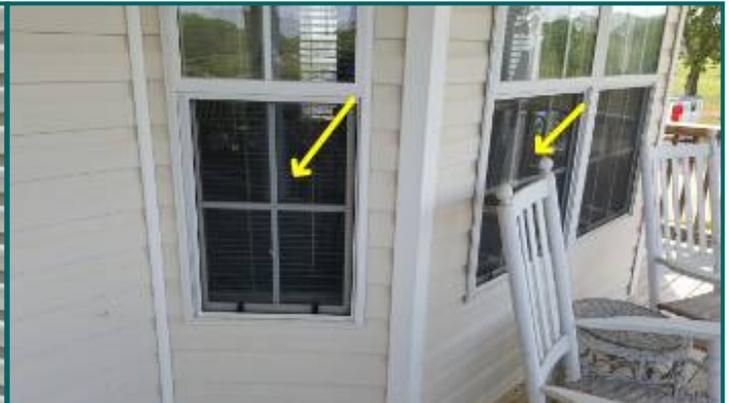
damaged screens on front

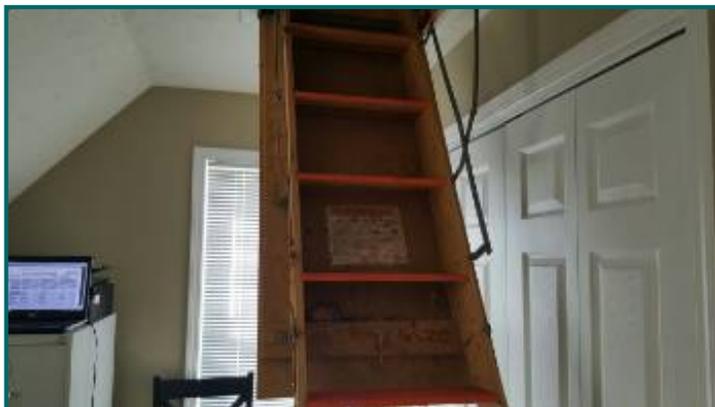
2.1. In the interest of improved energy savings, the attic access door or panel should be insulated. Please see the following website for more information
http://www.habitat.org/ic/env/pdf/Attic_Access.pdf

insulating attic access is beneficial

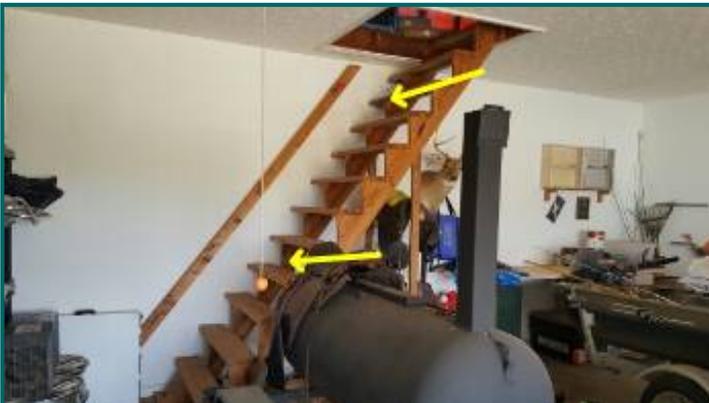
3.1. There is no guardrail. Any staircase and walking surface over 30" high should have a guardrail for safety reasons. Recommend a licensed contractor install per the generally accepted building practices.

missing guardrail in garage

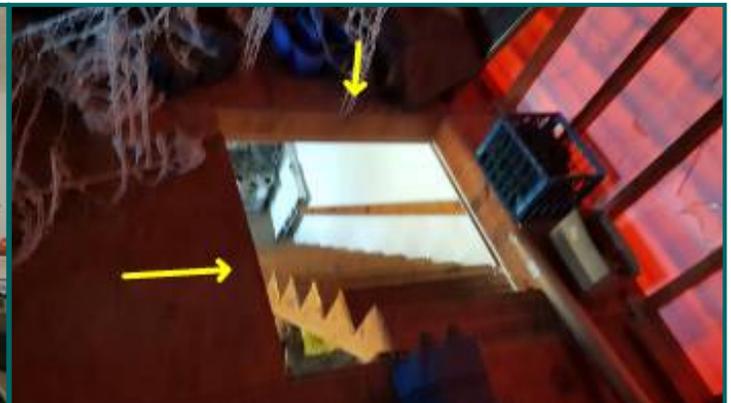
missing guardrail in garage attic

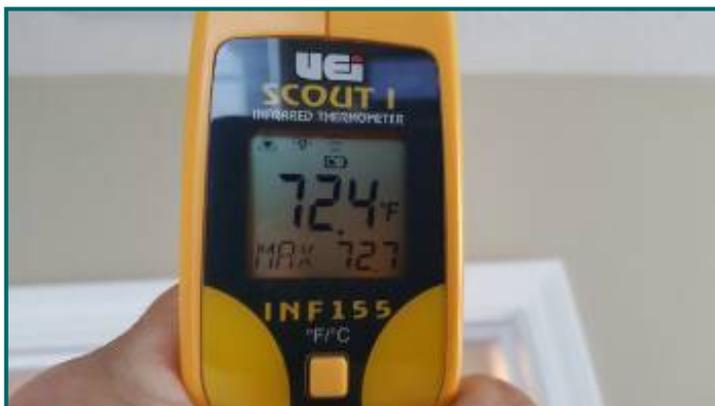
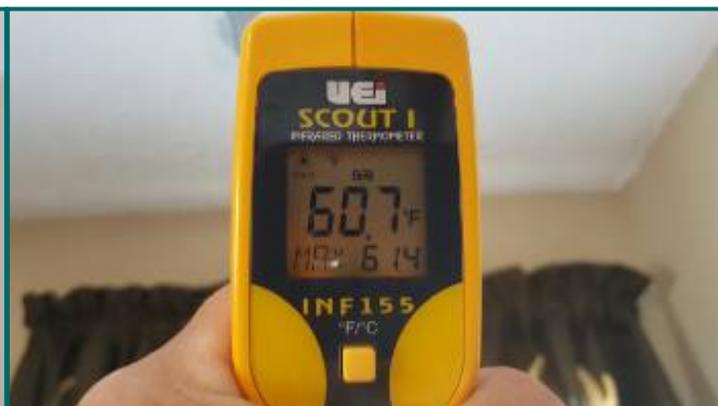
3.1. The temperature drop measured between the supply and return registers of the heat pump system serving the second floor is lower than typical. Decreased heat output by a heat pump system is usually attributable to low coolant pressure or the failure of a mechanical component. Recommend a qualified heating and cooling technician for further evaluation/repair and to check for other repairs that may be needed at that time.

return air temperature on second floor

supply air temperature on second floor

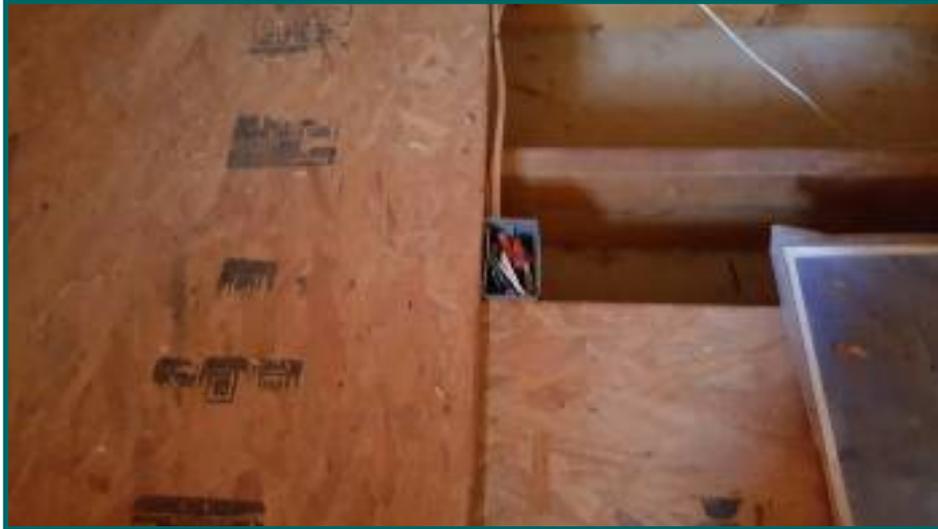
3.1. All junction boxes in the attic should be fitted with cover plates, in order to protect the wire connections. Recommend a qualified contractor add as needed and make any other repairs needed at that time.

missing junction box cover above garage

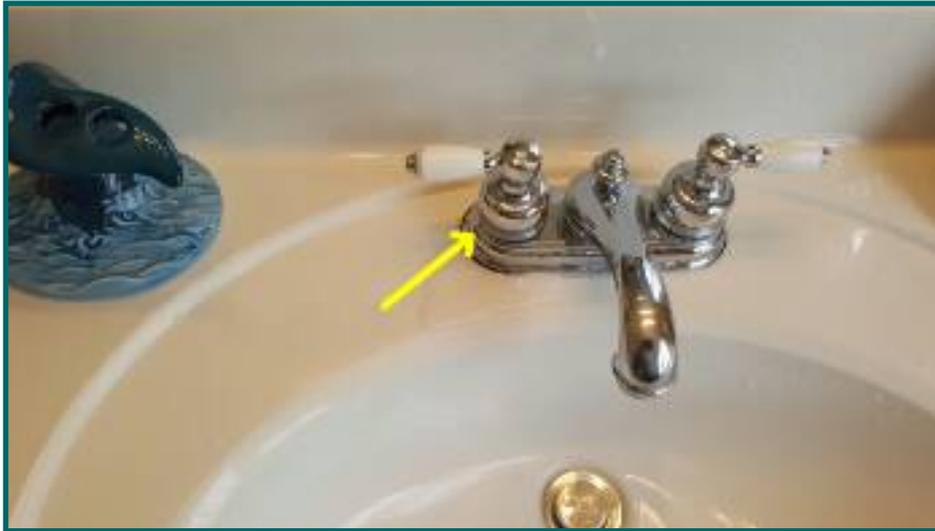
3.1. The faucet in the second floor bathroom vanity leaks, or it is deteriorated to the degree that replacement is needed. Services of a qualified licensed plumber is recommended.

leak at faucet

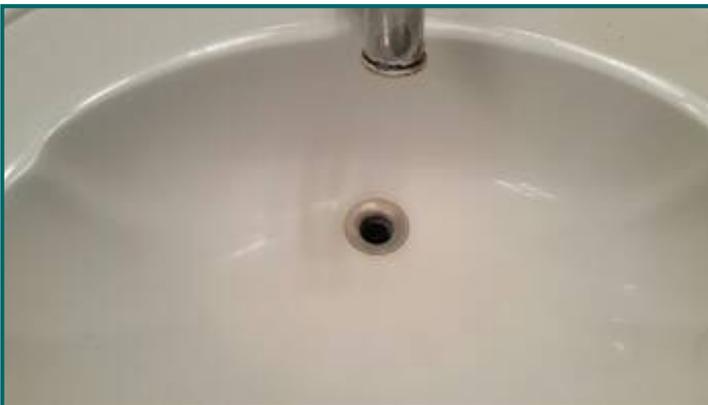
4.1. The basin stopper is missing in the master bathroom. Some repair is needed for proper operation.

basin stopper is missing

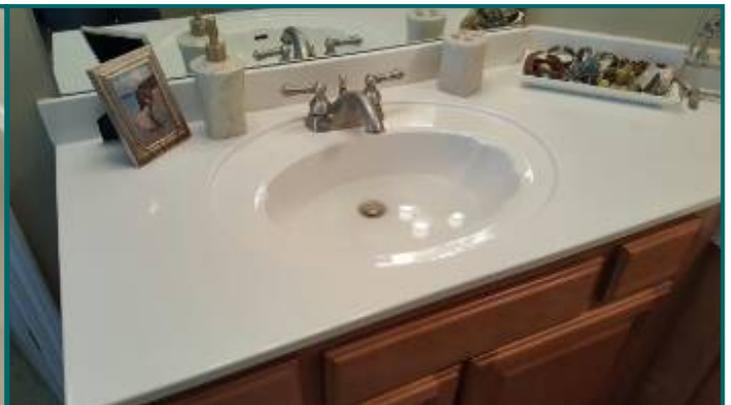
4.2. The sink drains slowly in the master bathroom. There may be some blockage either in the fixture or the drain line. Services of a drain cleaning service company may be needed.

slow drain

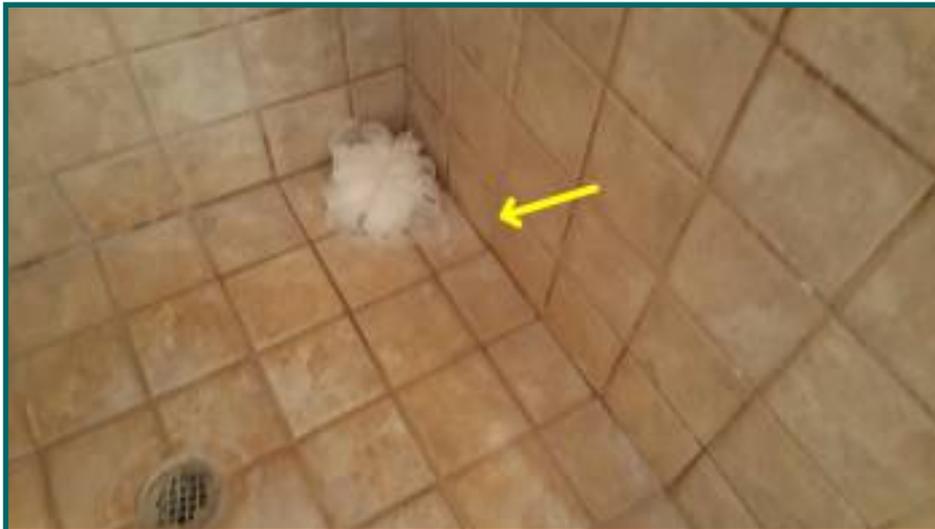
6.1. The master bathroom bath tub/shower enclosure needs caulk or grout repair to help prevent water penetration to the underlying materials. We are unable to determine condition of underlying materials. Recommend a qualified contractor repair as needed and ensure that the shower pan does not leak.

caulk or grout repair needed

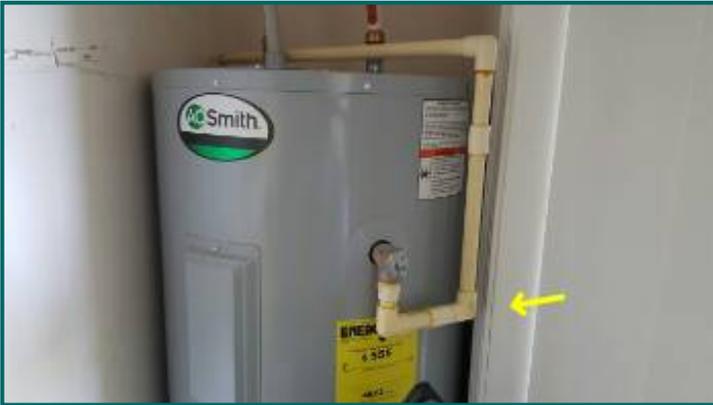
8.1. The relief valve at the discharge piping serving the Temperature and Pressure Relief (TPR) Valve for the water heater should be installed at the lowest point in the piping. The relief valves serves to empty the discharge pipe in the event the TPR is opened, and prevents the TPR from rusting and malfunctioning. Recommend a licensed plumbing contractor install per the generally accepted building practice.

relief valve needed at (TPR) valve

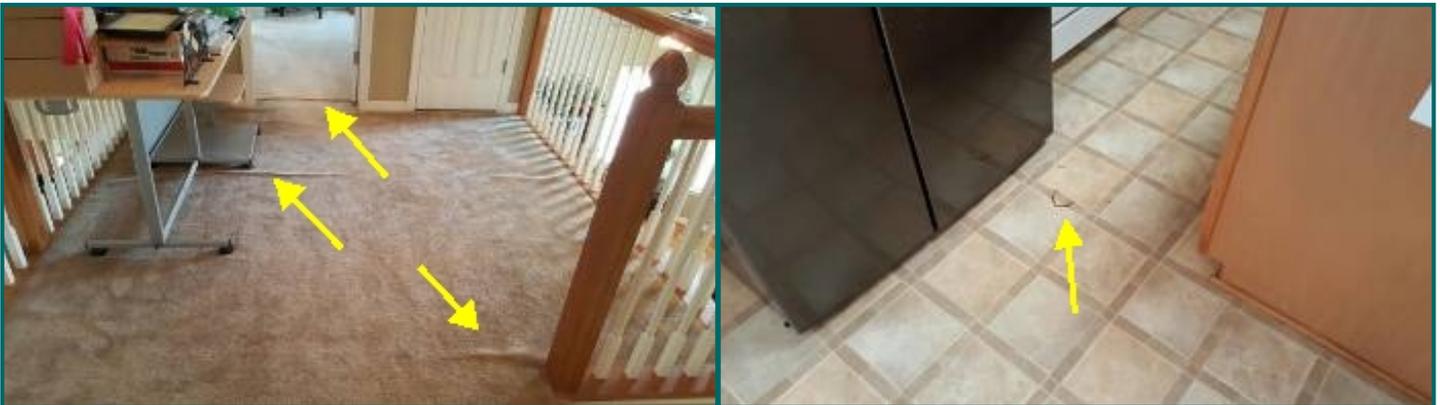
1.1. The vinyl flooring is damaged in the kitchen. Recommend a qualified contractor repair or replace as needed.

1.2. Loose or wrinkled carpeting was noted in the second floor hallway. Recommend a qualified contractor that specializes in carpet repair to repair as needed to avoid a trip hazard.

wrinkled carpet noted

damaged vinyl floor noted

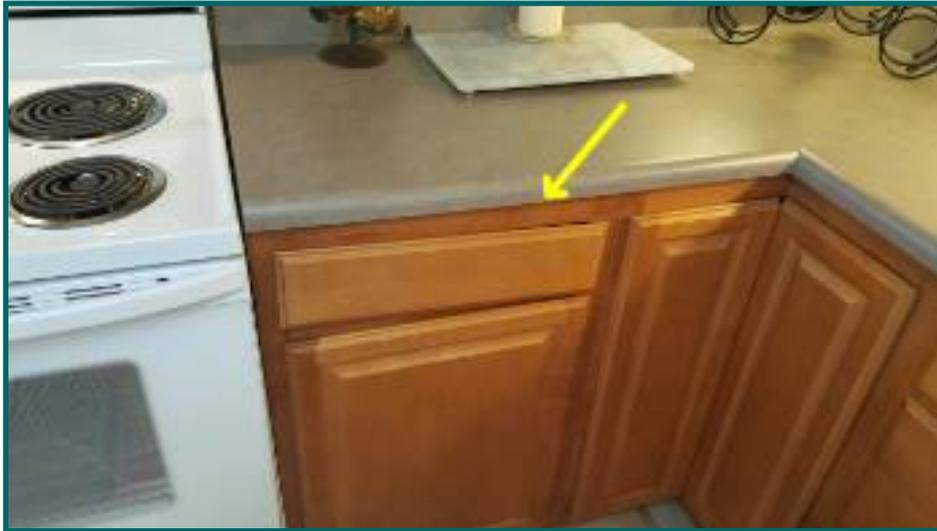
4.1. The drawer(s) are in need of some minor repair by a qualified contractor. The drawer is in marginal condition.

damaged drawer

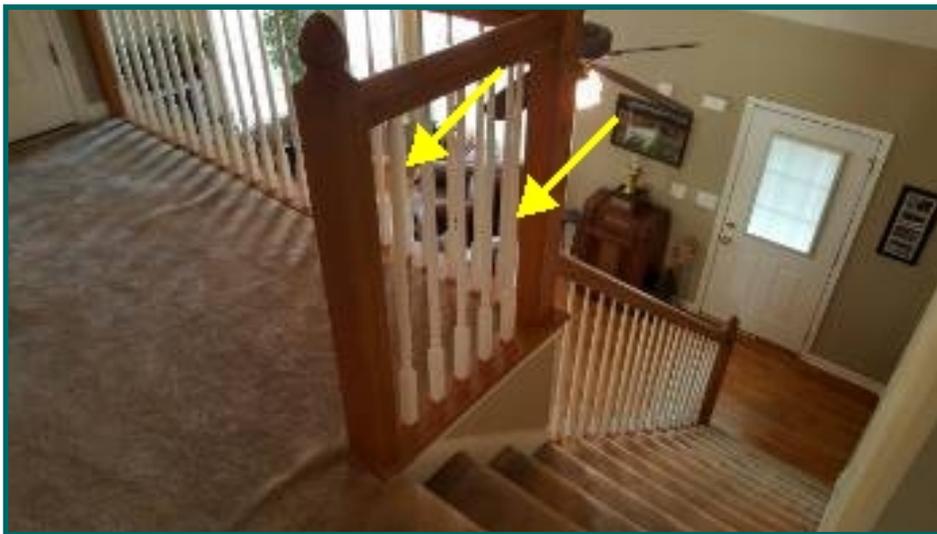
5.1. The handrail is not continuous over the full length of the flight of stairs from top riser to bottom riser. For safety reasons, you should consider that the handrail be altered or replaced with one of the proper configuration by a qualified contractor.

handrail is not continuous at the top
